The Locomotive

THE HARTFORD STEAM BOILER INSPECTION AND INSURANCE CO.

VOL. XXXVI.

INDEX TO VOL. XXXVI.—1926-1927

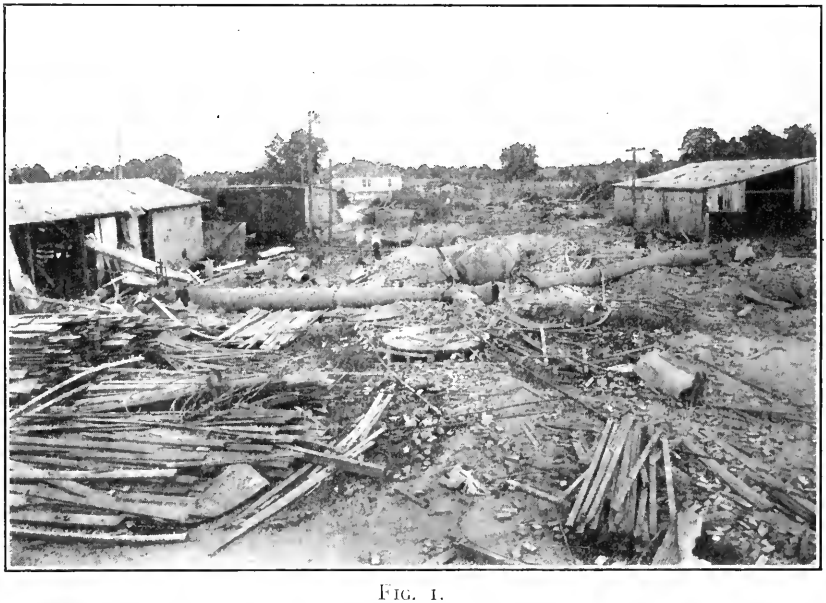
FIG. 1.

THE approximately simultaneous explosion of two boilers occurred August 14, 1926, at the plant of the J. H. Self Lumber Company, Ninety Six, S. C. Seven persons were killed and three were injured. The property loss was estimated to be $15,000. A general view of the scene is given in Fig. 1.

minor repair. With practically no load on the boilers during this interval, it is stated the firemen continued to pile on wood waste fuel with the result that the safety valves soon began to blow. These valves were said to have been set to relieve the pressure at 110 lbs. In spite of the relief afforded by the safety valves, the pressure on the boilers continued to rise, 140 lbs. having been noted shortly before the explosion by one of the survivors. A few moments after this observation both boilers exploded. The foregoing evidence, together with the violence of the explosion, would seem to indicate over-pressure, resulting from insufficient safety valve capacity, as the cause of the accident. As all of the mill employees were at work at the time, the

double riveted lap seam construction. One of them was said to have been 43 years old and the other one 25 years old, although they had been in the present location but three years. The 43 years boiler failed along a row of rivets in the longitudinal seams of the rear and middle courses, much the same as in the case of a lap seam crack failure. In this instance, however, there was no sign of a crack, the entire break being fresh. These two courses opened out flat and, together with the rear head, moved only a few feet from the site of the boiler room. They are shown in Fig. 2. The rear course and head, intact, traveled about 100 feet in the opposite direction. The dome of this boiler was blown a distance of approximately one-half mile.

Boiler number 2, said to have been 25 years old, failed by shearing all of the rivets in the girth seam between the middle and rear courses. The front and middle courses and front head, with most of the tubes, moved about 100 feet forward, while the rear course and head were blown about 600 feet to the rear. There was no dome on this boiler, and the boiler itself did not suffer general disruption. The boiler room, of course, was leveled, but the nearby engine room fortunately suffered little damage. The property loss might very easily have reached a far greater figure had any of the projected parts of these boilers gone in the direction of a nearby cotton mill, as the machinery of such mills is delicate and expensive. So far as could be learned, there was no insurance on this installation.

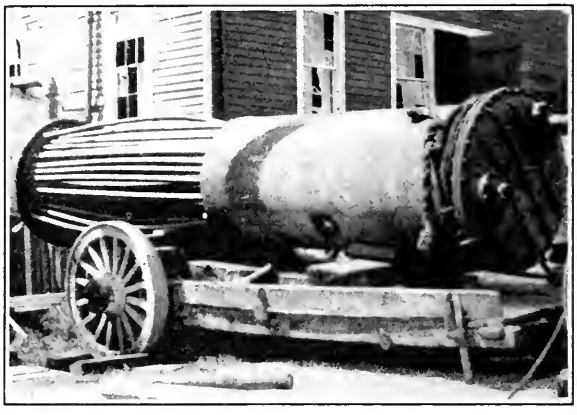
FIG. 3.

The vessel that exploded was a shell type ammonia condenser, part of a 40 ton compression type refrigerating system. It was 38 inches in diameter by 18 ft. long, and was constructed of 1/2 inch plate, in two courses. The heads were connected by a number of 2 inch tubes. An idea of the general construction of the condenser may be obtained from Fig. 3. Cooling water passed through the tubes and ammonia surrounded the tubes. One course of the shell was blown off, the rupture following the longitudinal and girth seams so that the plate opened out flat without any tearing. The rest of the vessel remained practically intact. Fortunately it had been installed out-of-doors, so the property loss was not as great as it undoubtedly would have been had the condenser been located inside of the building.

The cause of the accident is not definitely known. The vessel is said to have been operating under normal conditions when the explosion occurred, about 4 o'clock in the morning. The engineer, who was seriously injured, was standing nearby. It has been suggested that the circulating-water pump might have stopped or gotten out of order and thus cut off the water supply, allowing an excess pressure to build up in the condenser shell. Another possible cause, in view of reported condition of the welded seams, is that the failure started in one of these seams. The vessel had been in use for 12 years. The operating pressure was 170 pounds.

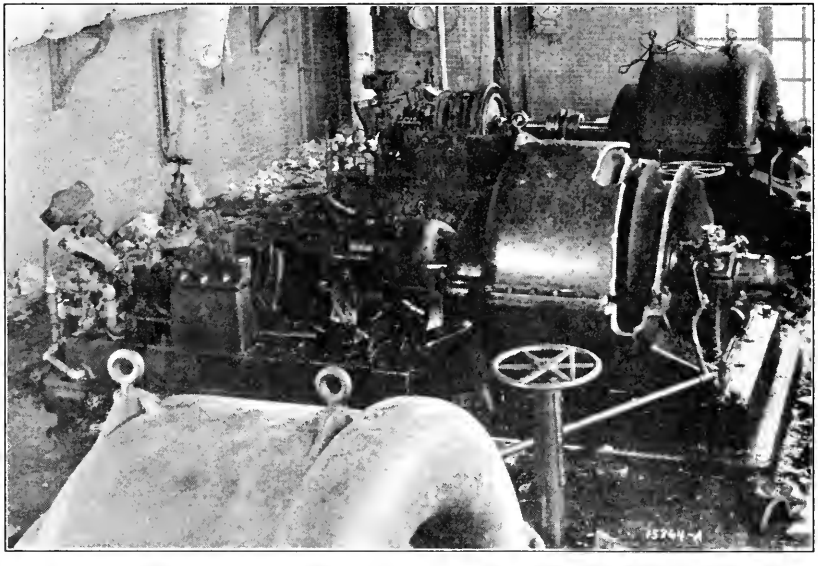
The compressor unit was used in connection with the sewage aeration system. At about 9:30 on the night of the accident the engineer discovered a leak in the oil pipe and immediately prepared to shift the load to another unit, so as to effect repairs. After warming

up Unit No. 4, he put it on the line and attempted to shut down No. 5, the defective unit, by tripping the emergency governor. Instead of slowing down, the machine seemed actually to gain speed. He then tried to close the throttle valve by hand, but found it jammed. As a last resort he started for the opposite end of the room to get a ladder by means of which he could reach the valve on the branch line from steam header to turbine. The explosion occurred while he was at some distance from the machine. This fact probably saved him from injury.

While examination of the wreckage confirmed the assumption that the machine failed by over-speeding, it did not determine, to the satis-

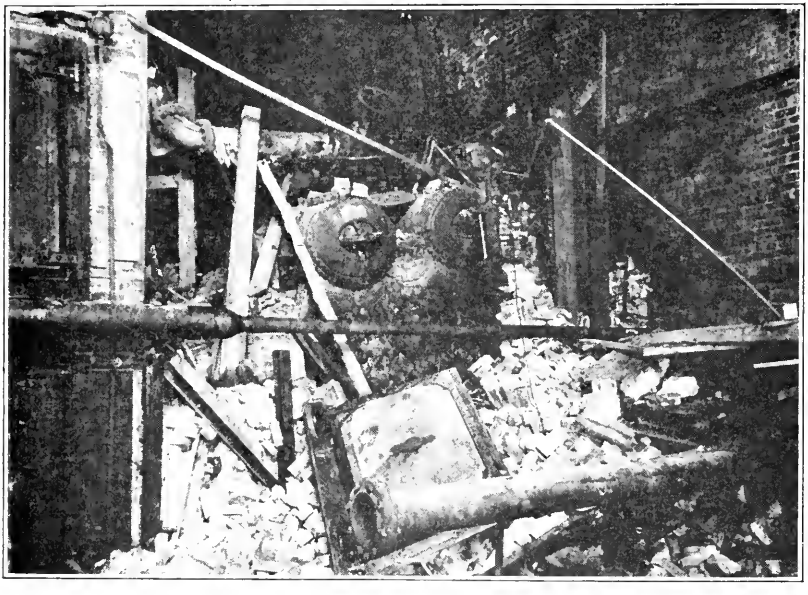
AN explosion that started when eight tubes in the lowest row of a water tube boiler were pulled from the front header, damaged not only the boiler but destroyed its setting, tore loose all pipe connections, parted the breeching, and blew a hole in a brick wall of the boiler room of Consolidated Ice Company, Inc., at Monroe, La., September 6, 1927. Fortunately, no one was near the boiler when it let go.

The explosion was cumulative in effect, in that when the bottom row of tubes pulled loose the energy released by escaping steam and

water raised the boiler from its setting and allowed it to crash downward four feet in such a way as to throw its full weight onto tubes which fell across a brick baffle wall about midway the furnace. Needless to say, this added considerably to the damage.

While the boiler was twenty years old it was apparently in good condition before the accident. Within the past two years it had been completely retubed and neither headers nor drums showed defects

when inspected. However, the lowest row of tubes had been the last to be replaced and, when installed, their ends had not been flared. This is believed to have allowed them to blow out under pressure.

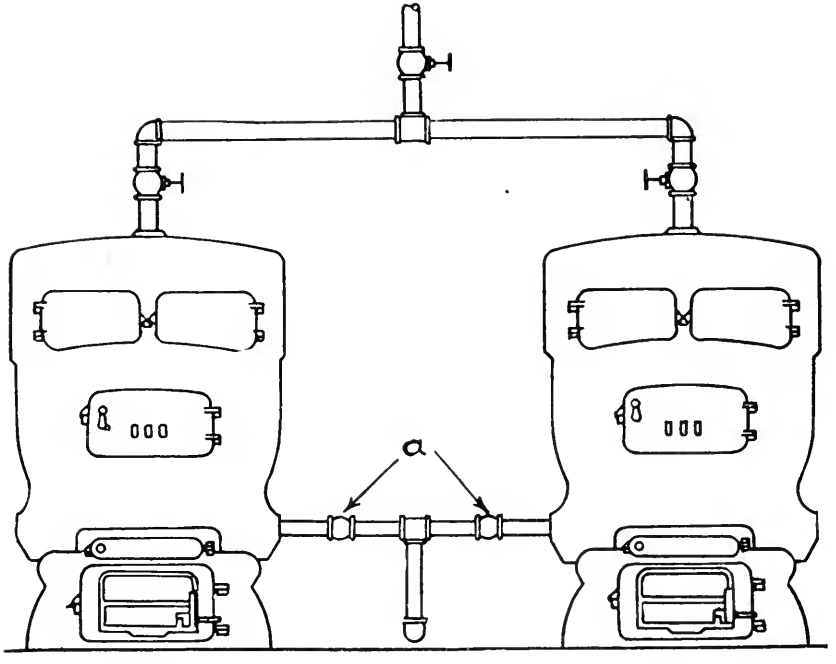
Figure 1 shows the layout of a two-boiler installation connected to a common steam pipe and receiving return water through a single return pipe. To prevent exchange of water between the boilers of such a system it is necessary to use check valves as shown at "a". With no check valves present the slightest difference in pressure on the water surfaces of boilers No. 1 and No. 2 will drive some of the water from the boiler under higher pressure into the other boiler. This condition carries with it the possibility of dangerously low water in one of the boilers.

To some it may seem almost unbelievable that any pressure difference can exist between two boilers connected to a common steam main. Nevertheless, experience has shown that this condition is possible. The explanation lies in the fact that the balance of temperatures and pressures in these low pressure systems is so delicate that it may be

upset by friction of the steam passing through pipes. Should boiler No. 1 be fired harder than No. 2 it will generate more steam. The increased flow of vapor through its steam pipe will create greater pipe friction, thus building up more pressure at the boiler's water surface.

A very slight pressure difference between the two boilers, caused in this way, is sufficient to bring about considerable variation in their respective water levels. Assuming a water temperature of 220 degrees

Fahrenheit, a pressure difference of only a quarter pound would cause a variation of approximately 7¼ inches in water level. It can readily be seen that this could uncover the highest part of the evaporating surface of the boiler having the higher pressure, cause overheating, and lead to cracking.

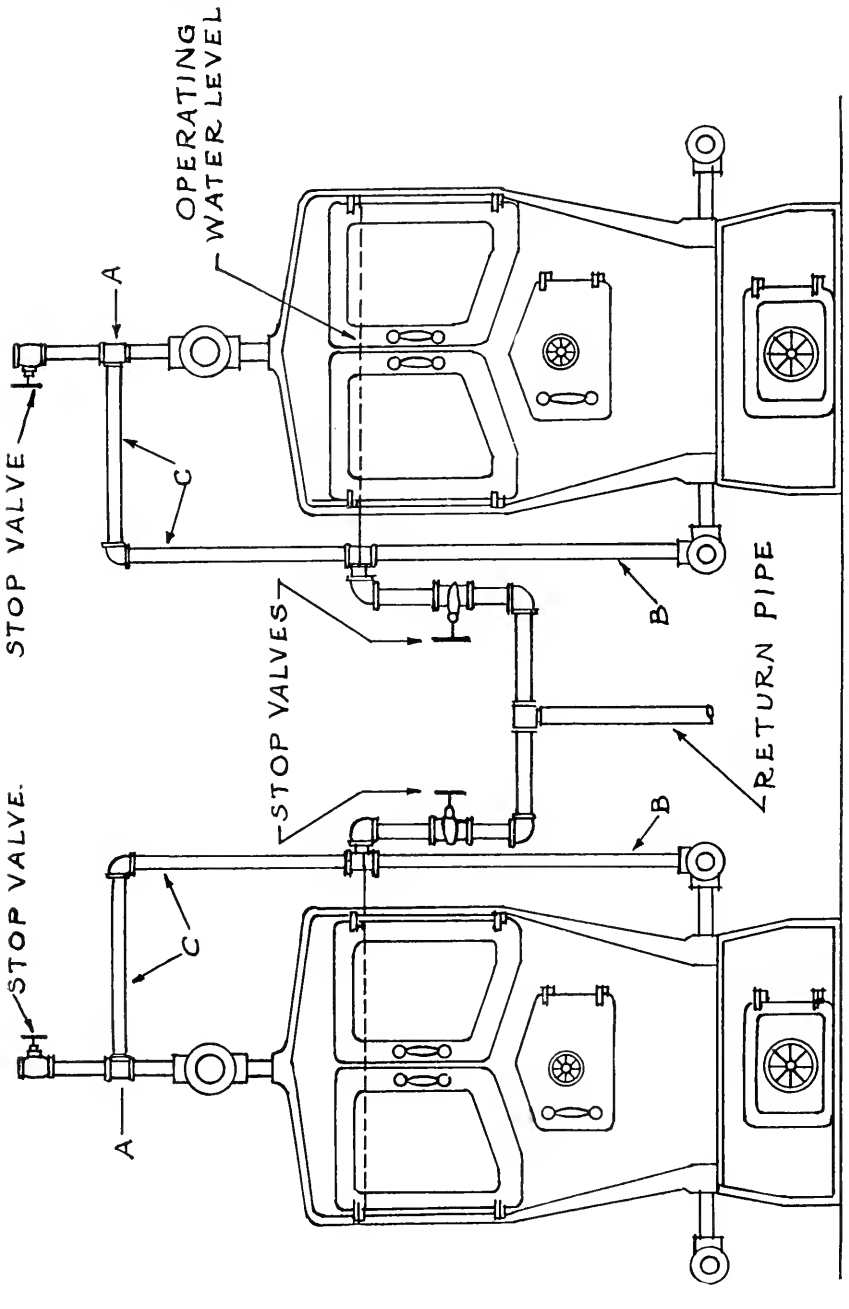
Figure 2

Examination of Fig. 2 shows that the return water piping is so arranged as to form a water column to balance the boiler water at the safe water level. But this, in itself, would not prevent steam pressure from backing water out into the system. To counterbalance this boiler pressure, a steam equalizing pipe is provided, as shown at "C", to produce static balance of the water in the boiler and that in the outside column. Should the reader have difficulty in understanding just how this is effected, the principle may be made clearer by considering the equalizing pipe "C" and riser "B" as just an extra section added to the boiler with free access to both the boiler's steam and water spaces. With this pipe arrangement water cannot be backed out below the safe level. It is important to note that the equalizing pipe must be of ample size and must have as few turns as possible, so as to avoid the effect of steam friction.

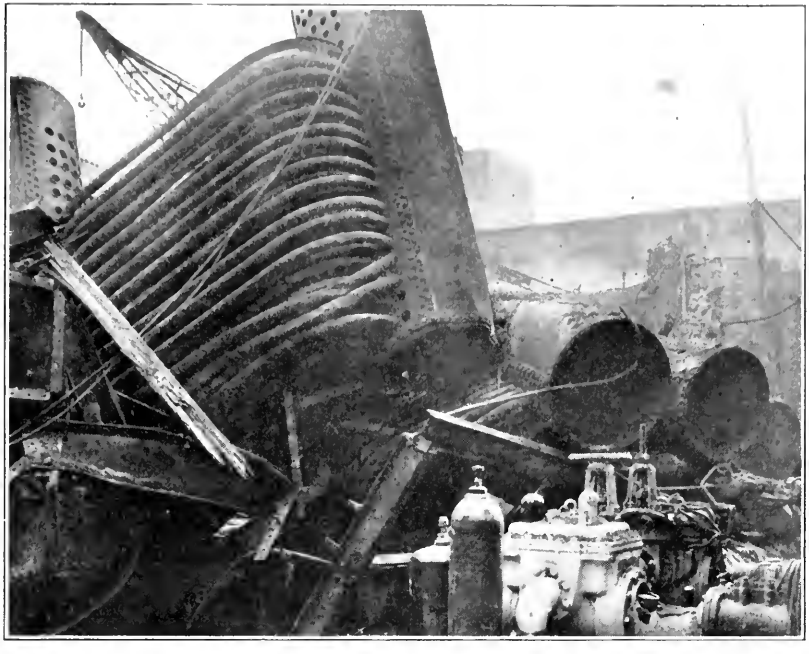
The boiler was operated at 155 pounds pressure and was rated at 300 h.p. Damage amounting to about $50,000 was covered by insurance although not in The Hartford Company.

Fluctuation of pressure inside a vessel acts on the head as though the latter were a diaphragm, causing it to move in and out — or breathe. As most bumped heads are constructed with a relatively sharp bend where they join the boiler shell, breathing aggravates the stress at that point and subjects the metal to bending fatigue.

It has long been known that metal at the heel of the head flange seems to be especially subject to corrosion, but it was not until recent years that a theory was developed to give a satisfactory explanation of this phenomenon. This theory, in brief, is that in a structure such as a boiler, those parts under the most severe stress fall easy prey to the electrochemical action of the water. Fatigue due to bending increases rapidly as the thickness is reduced by corrosion and, unless the condition be discovered, the outcome will be an explosion.

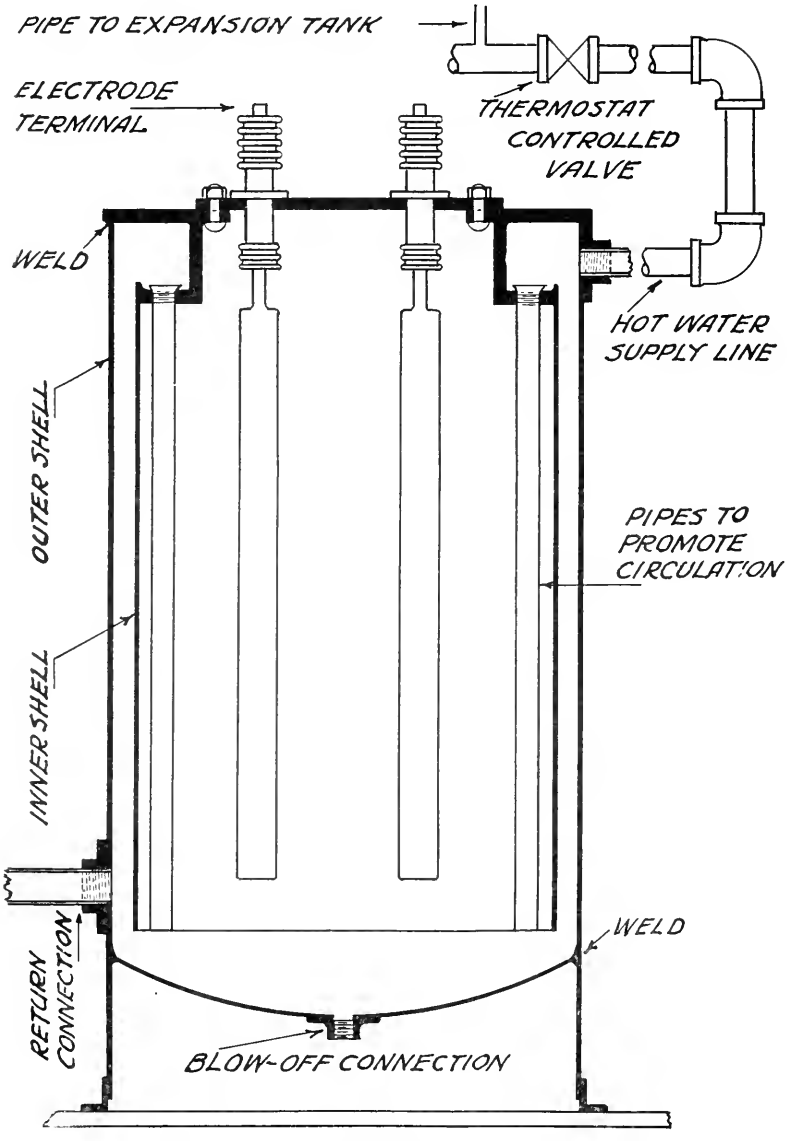
Several radically different explanations were offered for the explosion at Winnipeg. Some believed it to have been caused by overpressure, due to a stoppage of the pipe leading to the expansion tank. Others were inclined toward accepting the hydrogen explosion theory. A point that all were able to agree on was that the ¾ inch pipe to the expansion tank was too small for safe operation. This had, previous to the explosion, caused water hammer and surging when the thermostat controlled valve closed and caused the pressure to back up into the expansion tank.

From the diagrammatic sketch in Figure 3 it can be seen that in case an explosive gas were formed it would collect in the upper part of the electrode chamber, from which there was no provision for its escape. It is conceivable that enough steam and gas pressure could be

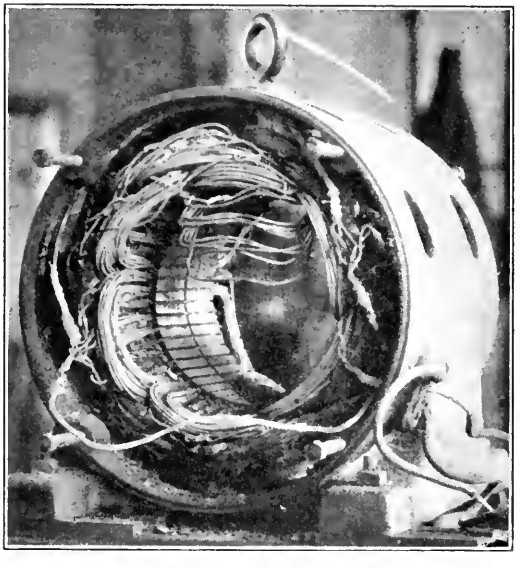
The underlying cause of failure of the motor herein illustrated was, of course, seizing of the shaft due to softening of the babbit by the heat of friction. For electrical machinery it is important to select only the best grade of mineral oil of a density that will allow the oil rings to pick it up and carry it readily. Too much oil should be avoided, for an excess may be drawn into the windings where it will cause deterioration of the insulation, collect dust and dirt, and eventually bring about a short-circuit.

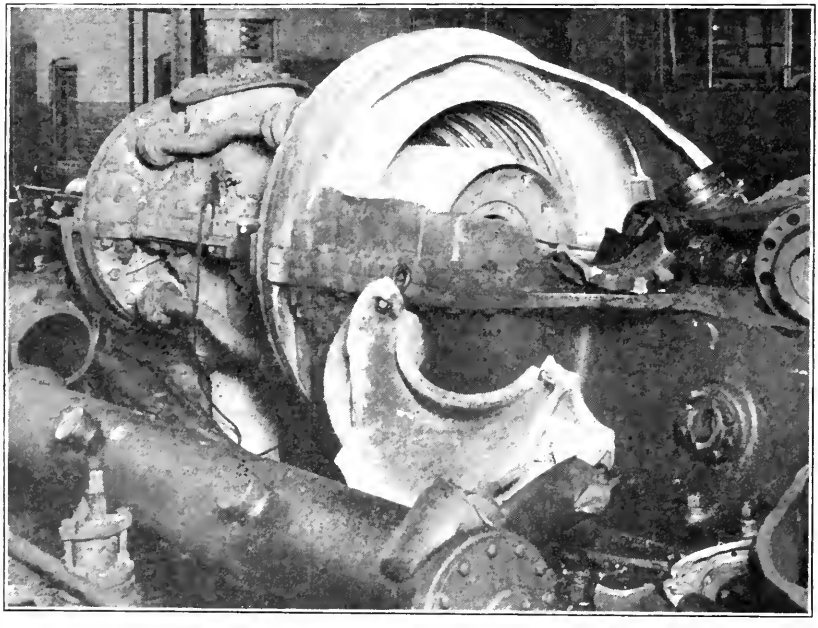
Figure 1

SUDDEN breaking of blades, probably caused by a slug of water coming through with the steam, led to the destruction of a 4,000 kw. turbo-generator at the plant of Indianapolis Power and Light Company at Indianapolis, Indiana, on April 28th of this year. When the clear, ringing hum of the smooth-running turbine suddenly changed to an ominous rumbling, attendants attempted to avert an accident by

tripping the emergency mechanism and closing the throttle valve. The break-up occurred about twenty seconds later. Fortunately, no one was hurt.

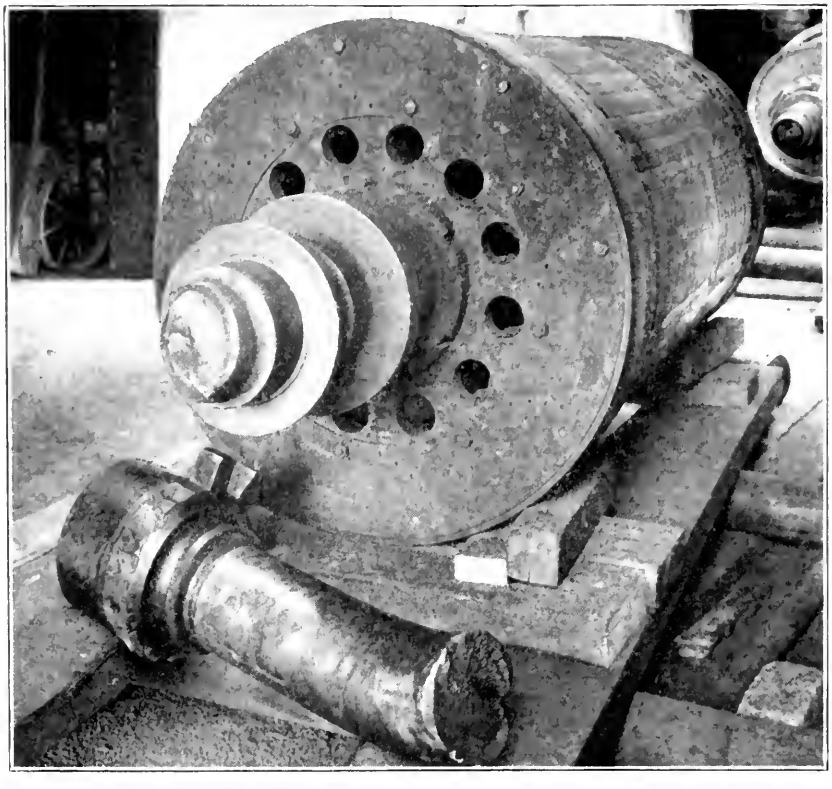
Figure 2

At 9:50 on the night of the accident the switchboard operator heard a low, rumbling noise which continued for about three minutes. During that time the meters indicated that the load was about 2,100 kw. This took a sudden drop of 800 kw. and shortly thereafter another drop of 500 kw. The operator saw that the field current and the exciter voltage

were normal and suspected that the load fluctuation might be due to a ground in the armature. It occurred to him also that the strange sound coming from the turbine might be due to water in the steam. He had signalled the boiler room to be on the look-out for this when he saw the operating engineer, whose attention also had been attracted by the unit's strange behavior, signal for him to take the unit off the line by opening the switch. While this was being done the engineer tripped the emergency mechanism and closed the throttle. Immediately thereafter the wreck occurred.

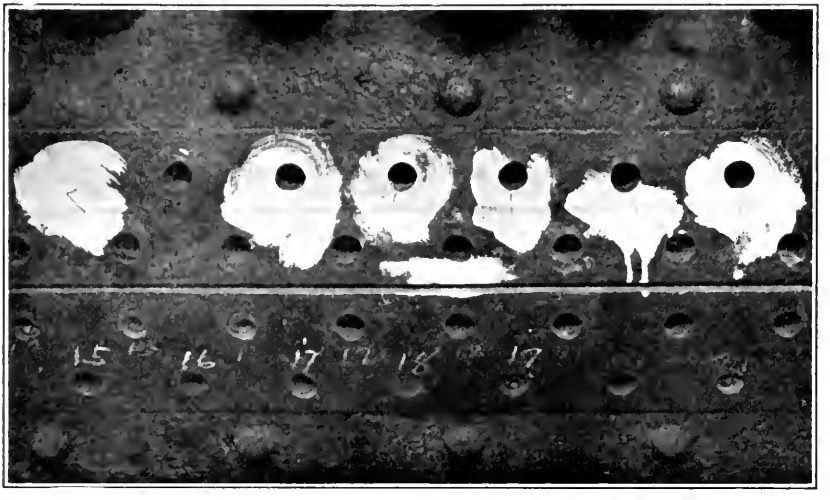
Well water in which the sodium carbonate to sodium sulphate ratio was 1.8 to 1 caused the retirement of this boiler and five others in the same battery. It is interesting to note that the cracks in this mud drum extend radially from the rivet holes rather than from one rivet hole to another, which is usually the case.

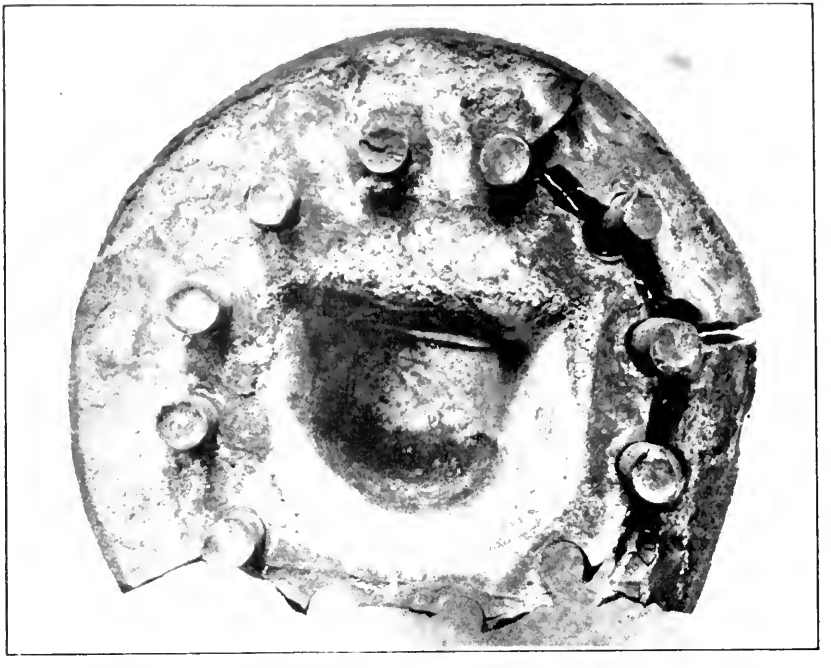
Creek water used in the boiler to which this cast steel blow-off pad was attached was naturally free from sodium carbonate. However, a method of feed-water treatment produced a sodium carbonate to sodium sulphate ratio of about 12 to 1.

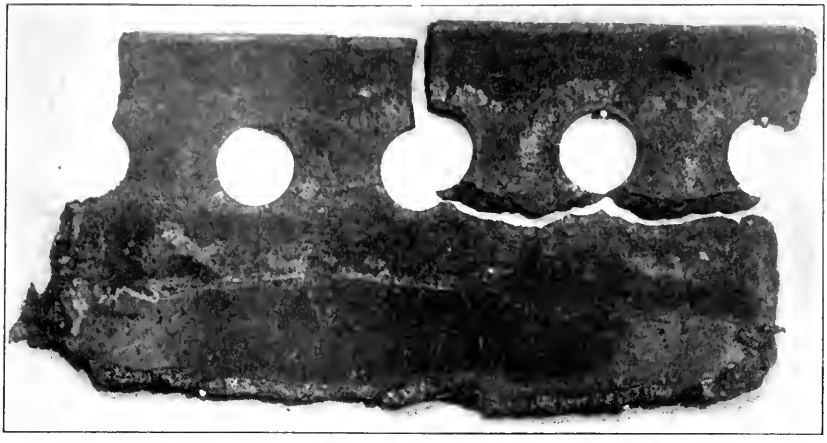
During a hydrostatic test to determine the seriousness of leakage at the girth seam of a horizontal tubular boiler a trace of salt was found around a rivet on the external surface of the rear head. Removal of several rivets disclosed caustic embrittlement cracks that affected the head seam throughout almost its whole circumference. A section of the cracked plate is shown above.

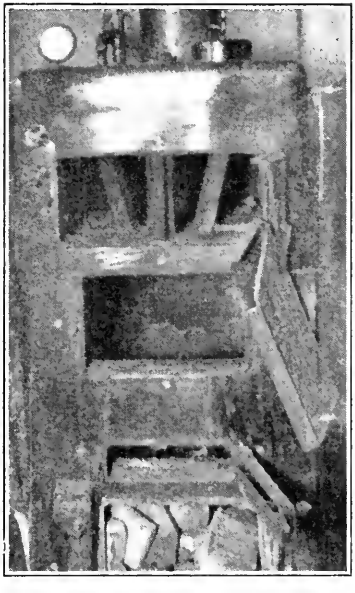
DEPENDENCE on the presence of an electrically-controlled thermostatic and pressure device to take the place of a safety valve cost the lives of a man and his wife when, on May 14th, it resulted in the explosion of a cast iron heating boiler used to demonstrate an oil burner in the show-room of a store at St. Louis, Mo. The control unit was designed to shut off the oil supply when pressure reached a certain point. After the accident it was discovered that the device had been disconnected to allow electricians to work on relays and switches. Without it, there was nothing to prevent pressure from increasing until it burst the boiler. Besides taking two lives, the accident scalded a woman seriously.

As may be seen from the accompanying photograph, quite a large piece was blown from the rear section of the firebox. There was no evidence to show that any defect existed before the accident.

Devices to control heat input of boilers are entirely practical and usually very successful from the standpoint of temperature control and fuel economy. In addition, they may even serve to keep pressure within allowable limits. But, as this case shows, for the sake of safety they should be augmented by the more direct and positive means of pressure relief which a safety valve affords. There is no need to point out how well a safety valve would have served in the case described above.

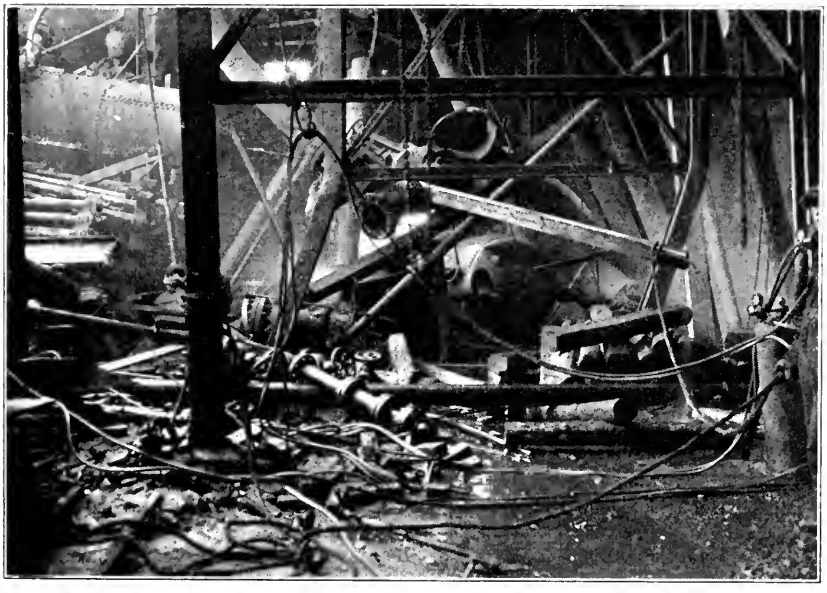
So Burchell saw no sign that all was not well: little could he guess what was going on inside the lap seam of the middle course of Boiler No. 7.

trouble. Of course, when they overhauled her four or five years ago they found part of the plate in the middle course a bit pitted, but that was not surprising after twenty years. So they just took out the pitted plate and riveted in a new piece, giving her two longitudinal seams in that course where previously she had had only one. After that, old No. 7 seemed just as sound as the day the erecting gang swung her into place.

Since then something had happened to that old piece of plate. Little by little a crack had developed along the row of rivets joining the old plate with the new. For a time there was plenty of metal left to hold the steam demon in check, but tonight old No. 7 knew that the end was near; slowly but surely she felt her strength giving out under the relentless squeezing of a force that was trying to burst the bonds that held it. If only a boiler could speak, No. 7 surely would have said something to Burchell as he passed by.

All in all, the casualty list was remarkably short, considering the narrow escapes of some of the men who were closest to No. 7 when she let go. Property damage, amounting to over $31,000, was covered by a policy in The Boiler Inspection and Insurance Company of Canada. The cut on a preceding page shows the damage to stokers and coal hopper.

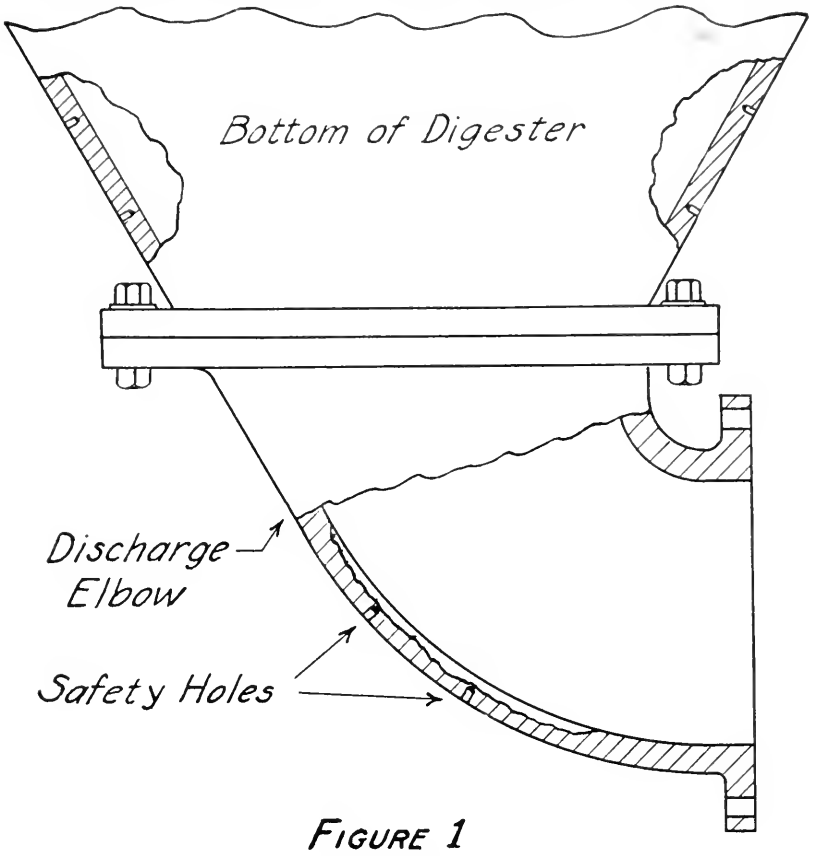
FIGURE 1

Many localized areas in these vessels need special precautions against dangerous thinning. As an example we can mention a discharge elbow at the bottow of a digester, rendering tank or any other vessel with a fitting or part through which stock is blown when the cooking process is finished. Erosion is concentrated and severe at the turn of the elbow. (See Figure 1) Frequently the metal wears com-

pletely through at this point, resulting in loss of material and possible danger to persons.

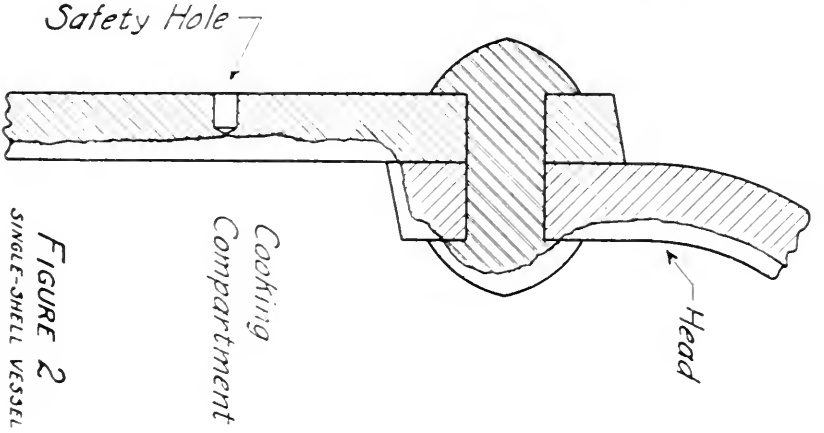
FIGURE 2
SINGLE-SHELL VESSEL

When metal on the interior or pressure side of the shell wastes away sufficiently to communicate with the bottom of a hole, steam or any other pressure will blow out into the room and give warning by being heard or seen.

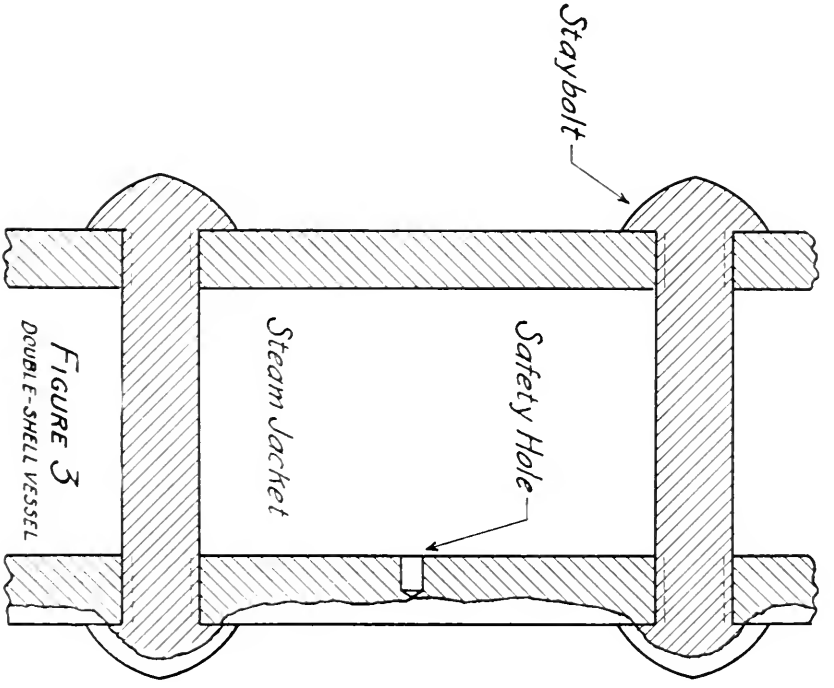
FIGURE 3
DOUBLE-SHELL VESSEL

In double-shell vessels such as jacketed tanks and hemispherical kettles, the inner shell is the one subjected to reduction of thickness and is therefor the one that must be protected by drill test holes. The holes should, of course, be drilled in the inner shell from the pressure or jacket side. (See Figure 3).

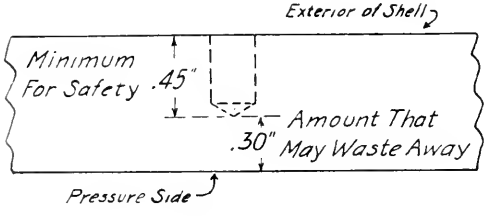
Figure 4

and the depth to which test holes should be drilled. (See Figure 4).

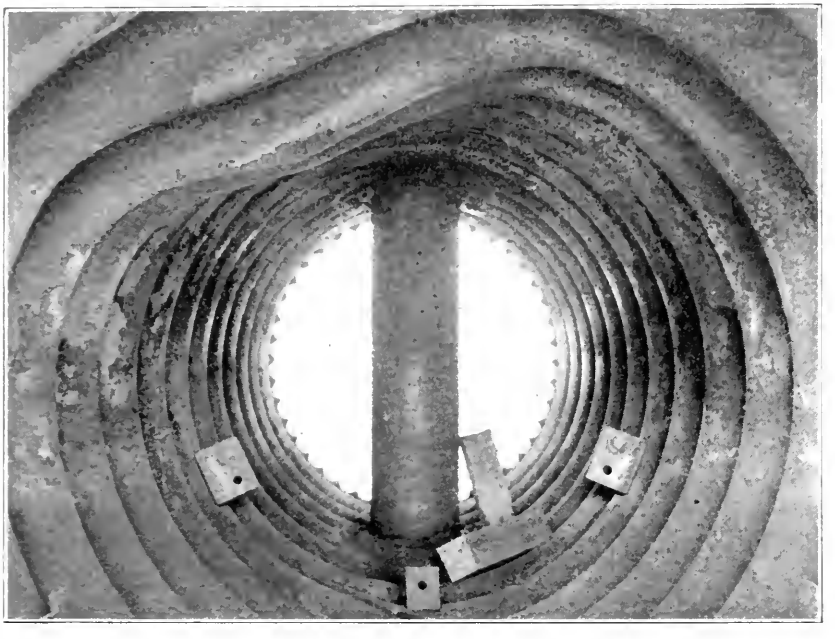
Cases where oil is deliberately fed into a boiler are not numerous enough to cause great concern. Usually when oil is present it is there quite by accident and by no design of the operator. One such case was discovered recently at a plant using steam coils to heat a tank of oil. When the owner applied for insurance an inspector found crown and firebox sheets bulged so badly they were in danger of collapse. Oil had entered the return line through a leak in the heating coils and had gradually accumulated until it comprised about 15 per cent. of the solution in the boiler. As none of the steam was used in engines, the operator did not think it worth-while to investigate the cause of the boiler priming. It was evident to the inspector that no one at the plant appreciated the danger of the condition.

effect is dependent on the free, rapid transfer of heat from metal to water, and when either poor circulation or some mechanical barrier such as scale or oil retards this heat flow the metal may be burned or softened to such an extent that it will collapse.

Oil is a better insulator than scale. Even a thin skin of oil resists the passage of heat so efficiently that wherever it forms the metal is almost certain to be damaged.

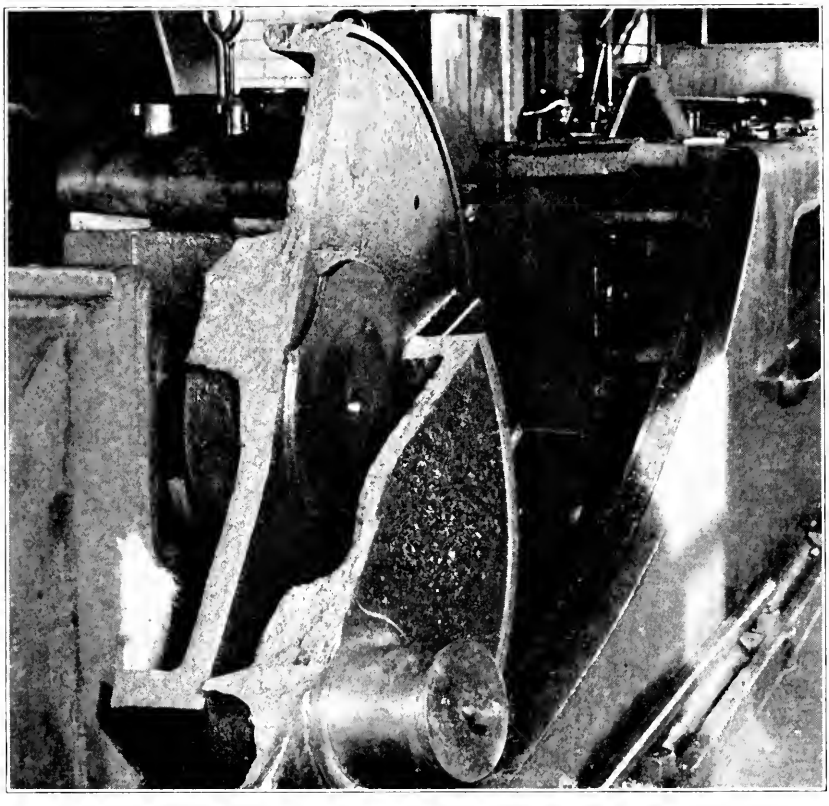
IT will take more than the accompanying photograph of an engine break-down to settle the old argument as to whether casting a semi-steel crank pin and crank disc together makes as strong a job as shrinking a steel pin into the disc. However, it is evident that the cast

pin shown here was sufficiently strong, for it withstood a tremendous shock while the disc itself broke in two.

This break-down occurred recently on a Corliss type engine and was caused by the piston rod breaking off underneath the nut at the head end of the piston. The nut dropped down, jammed between the piston and cylinder head, and broke off the whole end of the cylinder at the center line of the head-end valve chambers. At the same time the guide barrel, cross-head shoe, and crank disc were broken.

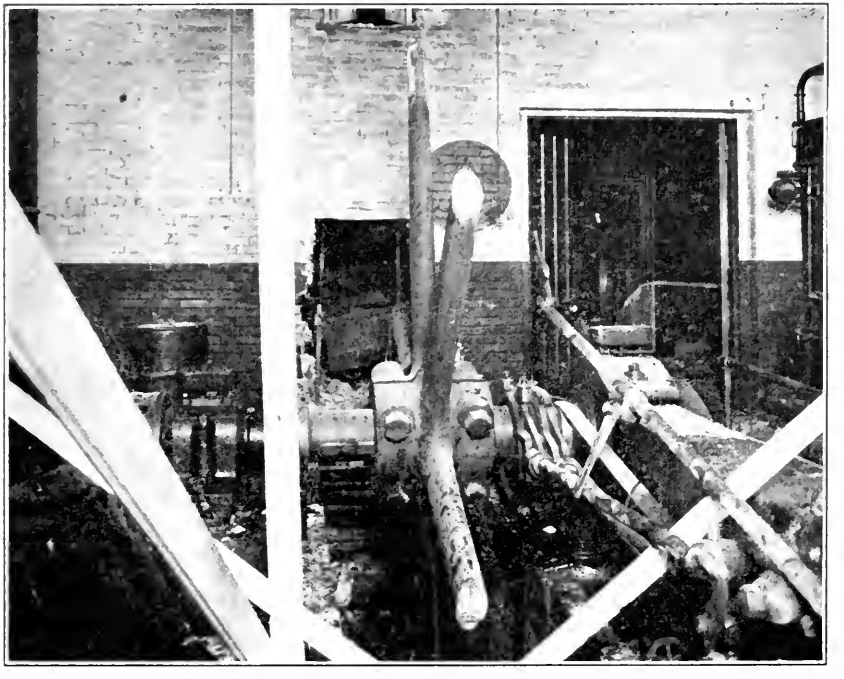
THE fourteen-foot flywheel of a Corliss-driven air compressor at the plant of French and Hecht, Inc., Davenport, Iowa, demolished the machine and caused extensive property damage when it burst, on the evening of February 8th. Three young boys who, after bringing lunch for their father, the fireman, lingered a moment

in the engine room to gaze in awe at the powerful engine, were the only persons in the room when the wheel let go. That they escaped with their lives was almost a miracle.

One piece of the wheel, weighing about 800 pounds, passed through the wall of the engine room, tore out two girders in the main factory building, and went on out through the roof to find a resting place in the coal pile of a neighboring plant 600 feet away. Another piece apparently went almost straight up in the air, for it came down vertically through the roof of the foundry and buried itself three feet deep in the dirt floor. A smaller piece dropped into the pattern vault and crushed a storage rack.

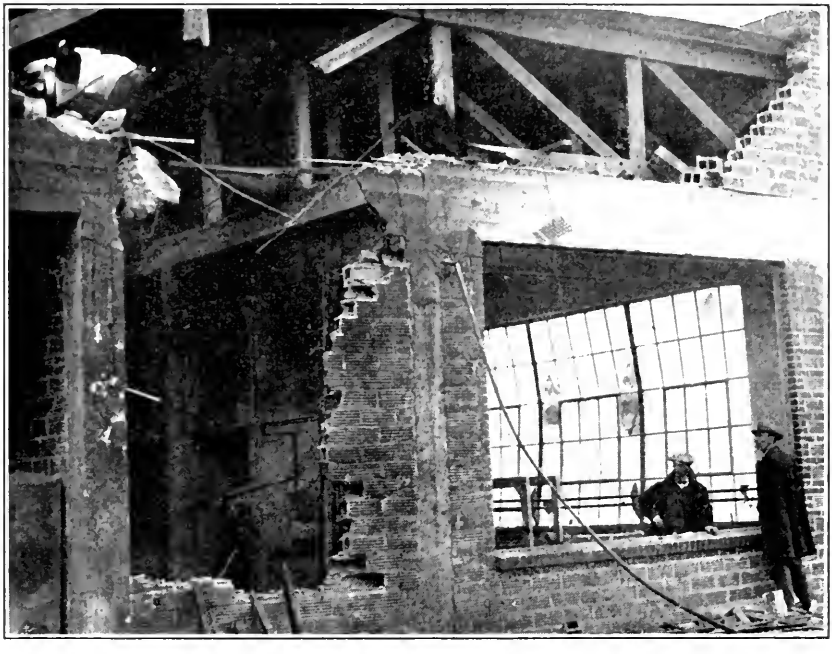
The boiler, a comparatively new one of the Scotch type, stood outside and about twenty feet to the rear of the factory building. When it exploded it went like a rocket through the rear wall and up through the roof, dropping back again into the building amidst a gang of workers. Fortunately, none of them was directly beneath it when it landed. The photograph is a view of the damaged building from the rear.

The boiler was used at the old plant only ten weeks before it was set up at the new location. Thus it is almost certain that deterioration could not have caused the failure. Nor was there any evidence to support the opinion that low water might have been the cause. In fact, the flue collapsed from the bottom, instead of over the fire where heat would have done the greatest damage in case of low water. From the distance the shell was thrown it seems apparent that there was plenty of water in it at the time, for a small amount would not have stored so much energy.

It was believed that the safety valve became inoperative, thus allowing a tremendous over-pressure to build up. According to a newspaper account, the valve was adjusted or repaired the night before the explosion.

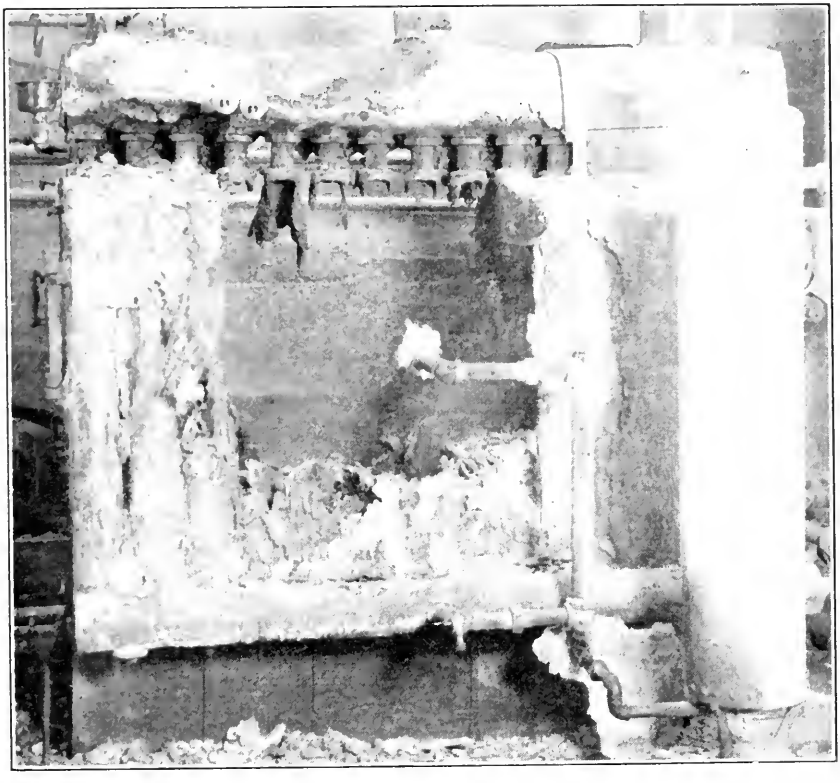
The boiler was used to supply steam for process work and heating at the plant of the American Abrasive Company, Westfield, Mass. The oil burner was of the gun type, manually controlled, and had no automatic regulation except a device which partly closed off the oil supply valve when steam pressure reached twelve pounds, and opened the valve wide again when pressure dropped to a pre-determined minimum. At seven o'clock on the night of February 3rd, which was Sunday, the attendant noted that the burner was working normally and that there was plenty of water showing in the gauge glass. Some time between then and seven o'clock next morning, when the first employee entered the building and heard the alarm bell which had been set ringing by the sprinkler system, the boiler went dry and was ruined.

In common with many other costly accidents, this one was due to a comparatively trivial cause. A plug dropped out of a two-inch opening in one of the radiators connected to the system, thus allowing all the water in the boiler to escape through the aperture in the form

of steam. Had the boiler not been set in a pit lined with cement the chances are it would have set fire to the factory. Heat was so intense that it melted a sprinkler head twenty-five feet away.

From the picture it is apparent that the boiler had to be scrapped. The loss was covered by a Hartford Company policy.

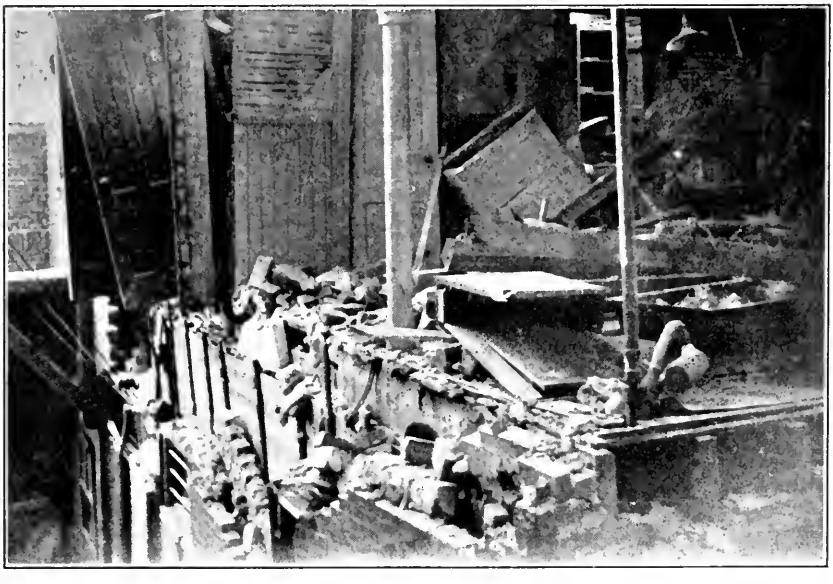
Mass., lighted the gas heater in his bathroom and, through oversight, neglected to turn it off after he had obtained enough hot water for a bath. In the early hours of the morning the storage tank let go and blew away the corner of the building. The blast broke windows and rocked houses for several blocks around. Telephone lines were so badly damaged that service in that neighborhood could not be reestab-

lished until late that evening. Figure 3 shows the wrecked portion of the building.

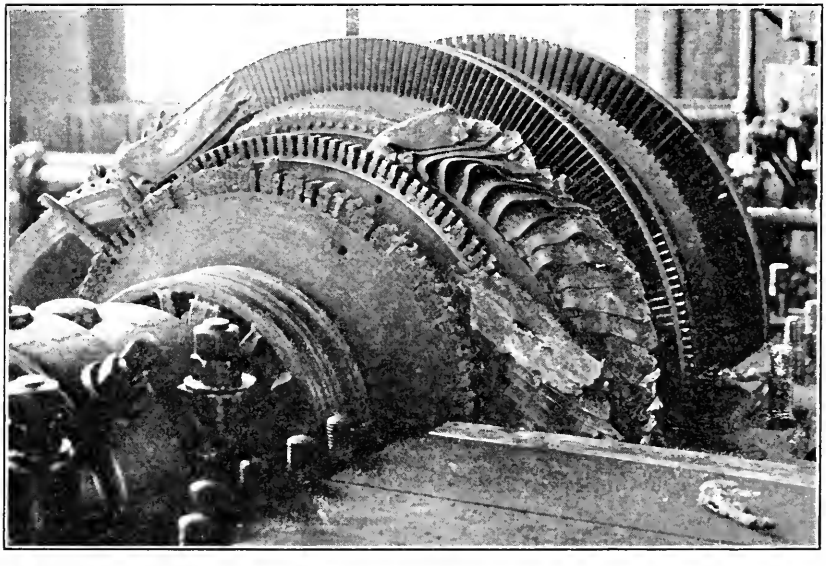
HAD not a quick-thinking engineer been in the immediate vicinity it is probable that the 1,500 Kw. mixed-pressure turbine pictured here would have been totally wrecked when derangement of the low-pressure control permitted a full flow of low-pressure steam while the machine was running without load. The engineer quickly closed both steam line stop valves and brought the turbine to a halt, but in spite of his promptness the buckets and blading of three discs and their corresponding diaphragms were entirely ripped away. An investigation after the accident revealed that a cast iron lever actuating the low-pressure inlet valve had broken.

When the accident occurred the engineer heard something snap and noticed the turbine pick up speed. Thinking that perhaps the butterfly valve in the high-pressure line had stuck open, he hastened to close the stop valve in that line. As this did not seem to check the speed he ran to the low-pressure stop valve and spun that closed. He

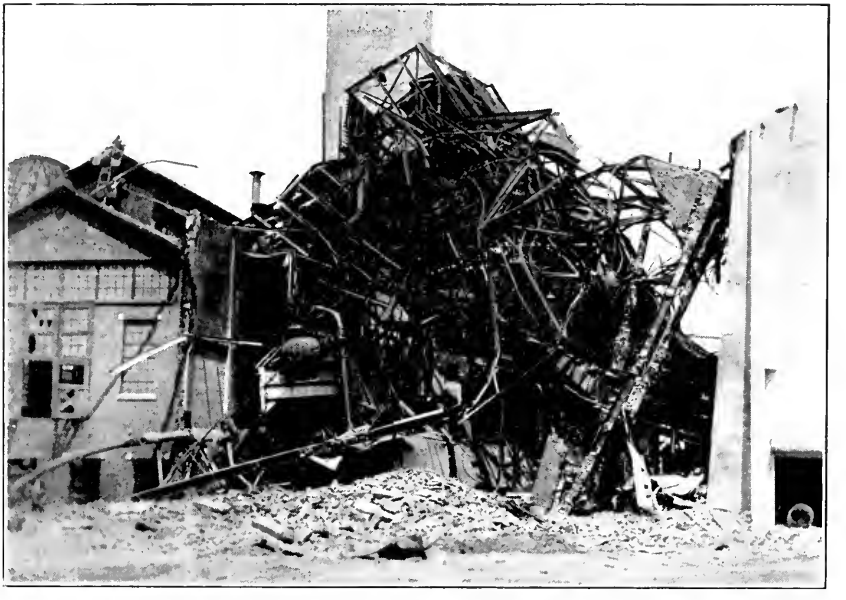
Mr. Straub found that the sample of plate which he examined showed numerous embrittlement cracks, and that the boiler water was

of the same type that had been found in embrittled boilers. In his opinion, the Crosset boiler was weakened by embrittlement cracks which undoubtedly caused the explosion.

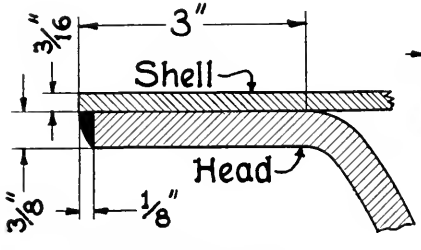
Figure 3.

The tank was 6 feet in length and had a diameter of 30 inches. Shell thickness was 3/16" and both the "minus" lower head and the "plus" upper head were made of 3/8" plate. Autogenous welding had been used throughout, Figure 3 showing the manner in which

the lower head was fastened. Failure occurred by shearing of the 1/8" section at the point where the welding joined the shell, the explosion hurling the shell and top head up through the roof and driving the lower head through the floor and into a room below. An examination disclosed no signs of distress in any part of the vessel other than the sheared seam, which very evidently lacked the strength that would have been obtained had the makers used the design shown in Figure 4, the method recommended by the A. S. M. E. Code for welding minus heads of unfired pressure vessels. There was no marking on the vessel to identify the maker.

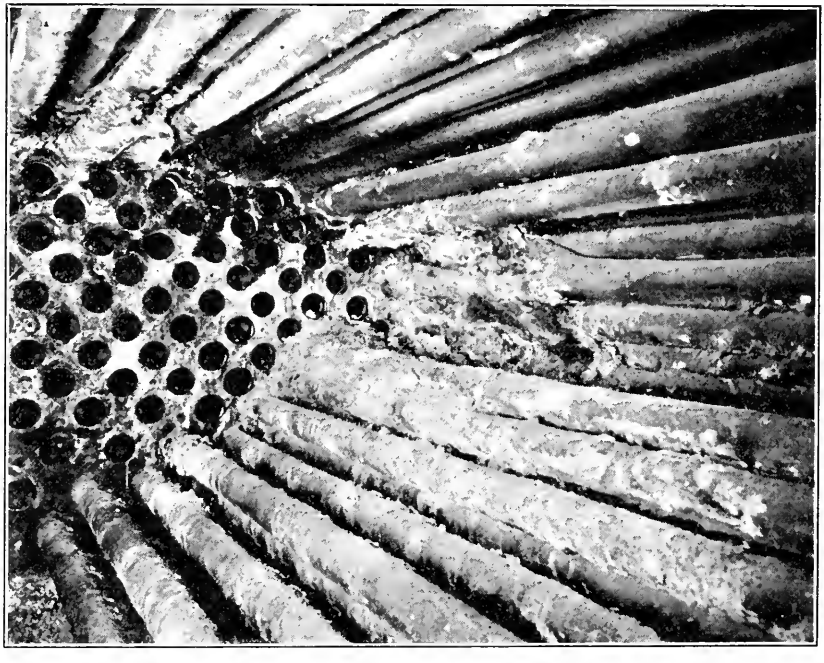
Figure 1

where they entered the tube sheet. In a short time the leakage became so troublesome that the boiler had to be taken out of service. Then it was found that the highly concentrated water, leaking out at the water-tube ends, had deposited a hard-baked, cement-like substance that literally matted the tubes together for a distance of four feet from the tube sheet, as shown in Figure 1.
